**INSPECTION REPORT BVFW/SHZ/2016/11-001**

<b>PROJECT:</b> Square tube	<b>Ref:</b> BVFW/SHZ/2017/11-001
<b>BV Client:</b> Changsha Hunan Steel Co.,LTD.	<b>P/o nr:</b> BVFS-SHZ-17/061-PO <i>(client to BV)</i>
<b>Manufacturer:</b> Changsha Hunan Steel Co.,LTD.	<b>P/o nr:</b> / <i>(client to Manufacturer)</i>
<b>Inspection requested by:</b> Changsha Hunan Steel Co.,LTD.

Item No.	SUPPLY / SUBJECT OF INSPECTION	Purchase Order	QTY (FT)
1	PRODUCTION INFORMATION/ EN10210 S355J2H	HNSCW172109L DX	118

Requested by **Changsha Hunan Steel Co.,LTD.** , BV-Fairweather inspector Mr Honggang Ma performed the third party inspection for the Square tubes at **JINAN** shop during Nov. 21<sup>st</sup>~ 26<sup>th</sup>, 2017.

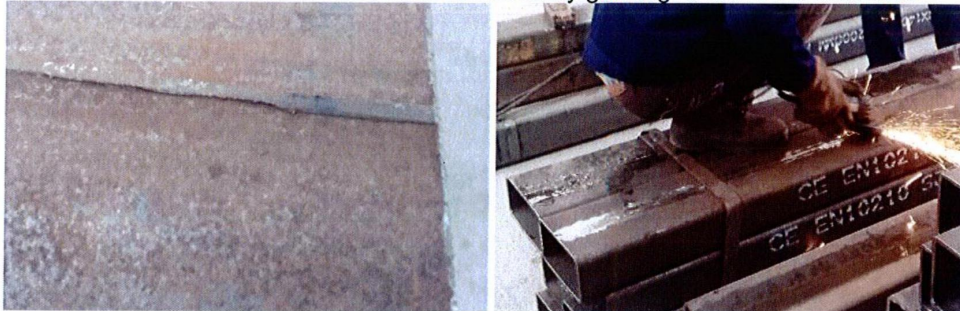
One uneven outer weld seam had been removed by grinding to within the tolerance

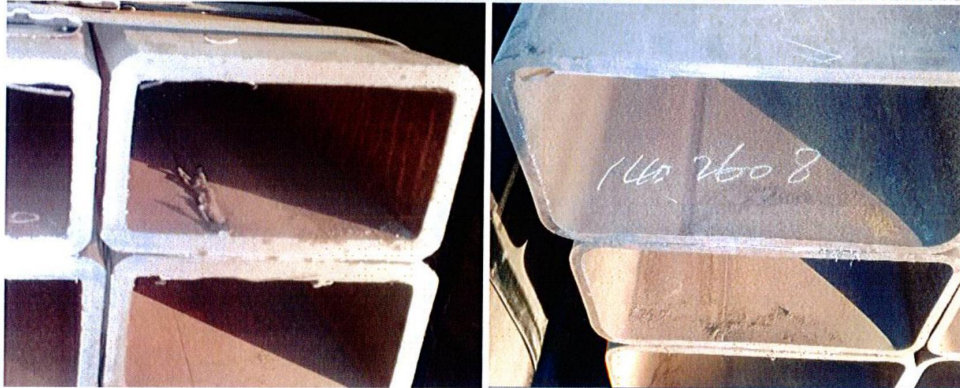
Some Inner weld seam had been remained and some inner weld seam had been removed
