Inspection Order No. : IN-TJ-5601-11488

**INSPECTION REPORT**

- Description and Quantity of  
Pipe EN10224 S275 508mm x7mm 85pcs  
Pipe EN10224 S275 508mm x9mm 625pcs

- Inspection Date & Place: Jan.10-11, 2012, Cangzhou, Hebei

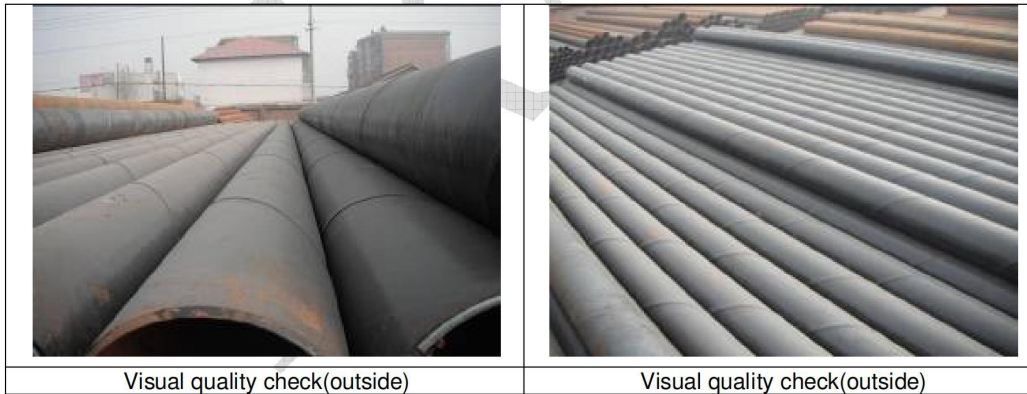
1.1 The pipes were coating with black paint and stacked on the ground.

Visual quality check(outside)	Visual quality check(outside)
