Inspection Order No. : IN-WH-5302-15015
BOSS No. : N/A
Page No. : 9 pages
Date of issue: Aug.31st, 2015

INSPECTION REPORT

- Description and Quantity of Commodity: SMLS STEEL PIPE, 14MoV63, Φ153mm×25mm 10pcs
SMLS STEEL PIPE, 14MoV63, Φ194mm×25mm 9pcs

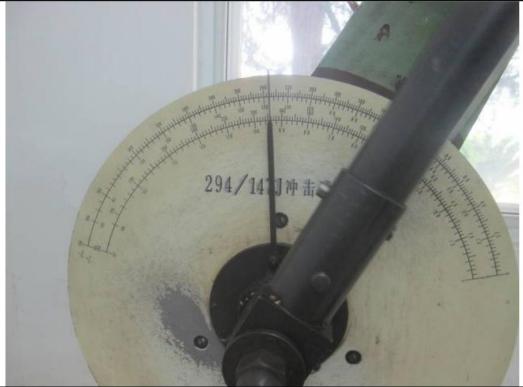
<p>Impact test</p>

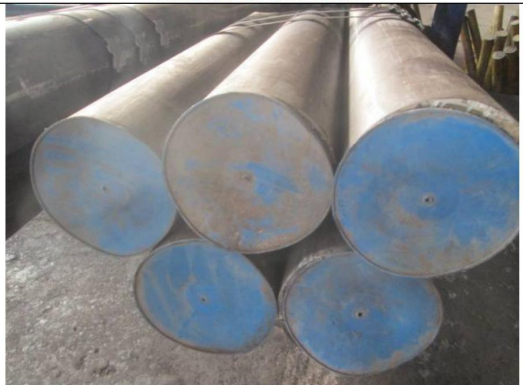
- The end of pipes was protected by plastic cap.
- The pipes were fastened with steel belt.

<p>Packing Check</p>

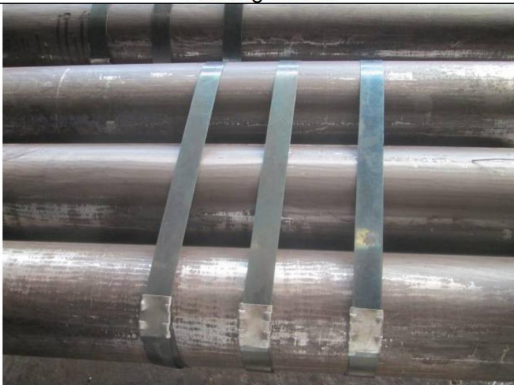
Packing Check	Packing Check
